**272 North Front Street
Wilmington, North Carolina**

Summary

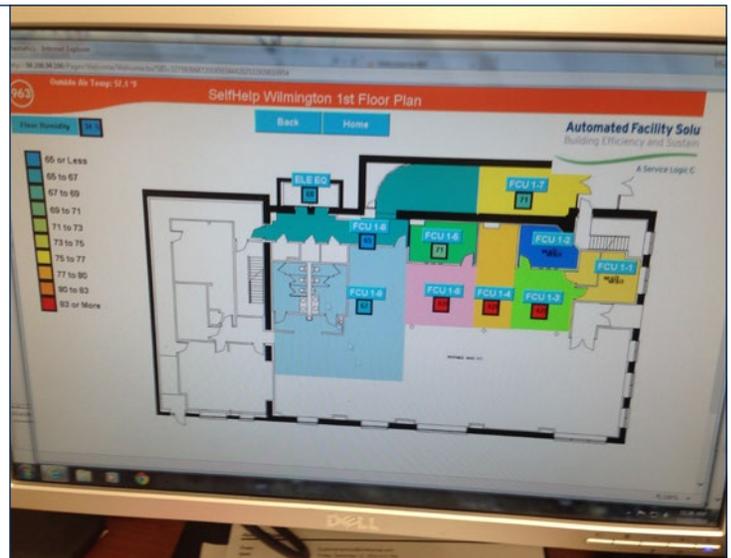
Figure 2: A screenshot from the building management system's online monitoring platform.

Building Management System. In September 2012, Self-Help installed a building management system that includes controls for the rooftop chiller plant, 59 fan coils monitors over five floors, and HVAC controls for the elevator bay. Previously, these mechanical components were controlled with a pneumatic system. The new system allows the property manager to create setpoints for heating and cooling levels to optimize system operation based on building use throughout the day, overnight, and when the building is unoccupied.

In addition, the Trend Controls IQ system allows Self-Help's property management team in Durham to monitor building performance remotely via the Internet. This remote-access capability benefits Self-Help's portfolio as a whole, as it allows the company to bring a sophisticated,

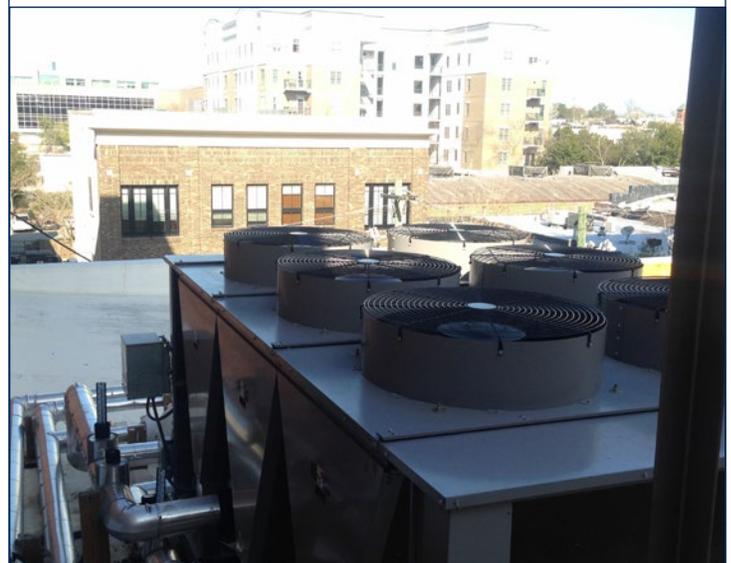
Figure 3: The building's chiller was replaced in 2013.

Chiller Replacement. In July 2013, the company replaced the building’s chiller plant as part of the property’s capital improvement program. The new 77.4-ton, energy-efficient unit, with an Integrated Part Load Value (IPLV)³ Energy Efficiency Ratio (EER) of 15.5, was installed at a cost of \$89,089. A Progress Energy Utility rebate offset \$2,709 of the cost, lowering the effective cost to \$86,380.

The new unit improved indoor comfort and reduced maintenance needs. According to the Property Manager Chip Forsythe, prior to the retrofit, the previous chiller required frequent service calls for the unit and additional maintenance for the building. “Even when the unit worked well, it didn’t do the best job dehumidifying the air, which also meant condensation on chiller lines above the dropped ceilings,” Forsythe noted. “We were constantly replacing ceiling tiles, five to six a month. Now we may only do five a year.”

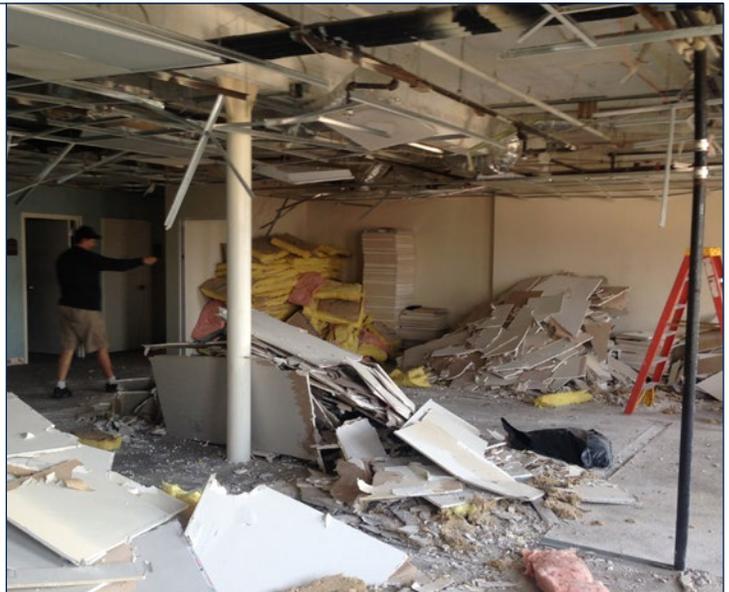
Figure 4: An office suite on the building’s fourth floor will be built out to include energy-efficient lighting and other features.

commonplace and lead to steady improvements in energy use. Typical features, as seen in a fourth floor accounting office currently under construction (shown above), include new perimeter heating units, high-efficiency fluorescent lamps, and LED exit signs. The incremental costs of these measures are not tracked in detail; rather, they are considered part of good practice and in some cases are borne by the tenants and charged against tenant improvement budgets. In addition, common space improvements are ongoing, particularly in circulation cores on each floor. As major tenants depart, the team seeks cost-effective upgrades, including the replacement of obsolete T12 lighting and the addition of motion sensors. Additionally, the company plans to convert existing stairwell lighting to LED lights in 2015.

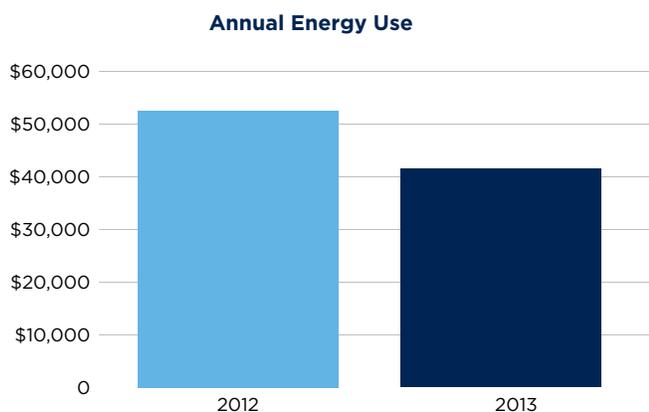
Figure 5: Annual energy use of 272 North Front Street has declined.

Property performance improved following the retrofit efforts. In 2013, energy costs declined 21 percent from the prior year, equating to more than \$11,100 in annual energy costs. These savings were tracked using the Environmental Protection Agency’s Portfolio Manager, a free tool that property and portfolio owners can use

Property Improvements	2012	2013	Improvement (%)
Normalized Site EUI	61.3	44.2	28%
ENERGY STAR Score	62	84	35%
Annual Energy Cost	\$52,618.32	\$41,511.87	21%
Annual Water Cost	\$3,499.87	\$3,040.86	13%
